Entry, Descent & Landing and Mission Outcome

Dr Jim Clemmet
Beagle 2 Chief Engineer

UK Space Conference
14th July 2015

Beagle 2 Discovered

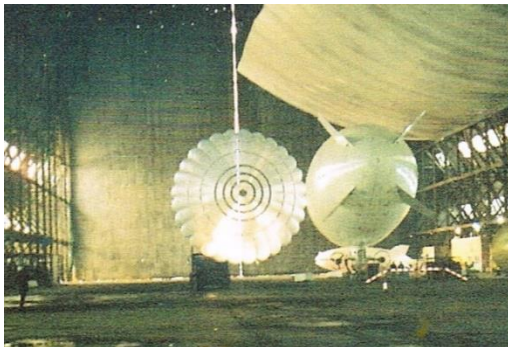
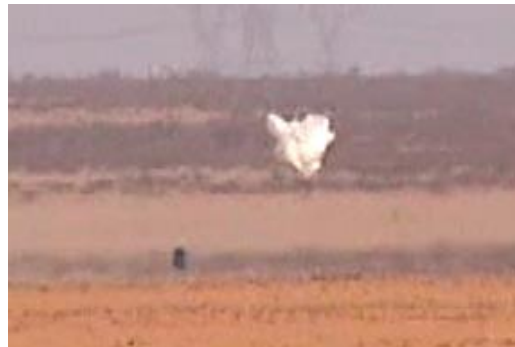
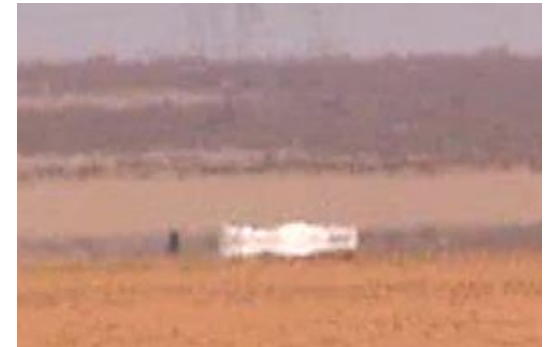
From drop tests, the collapsed parachute is estimated at 4m spread, consistent with HiRISE image

Another 26 opportunities with only pyro NSIs non-redundant;
Aeroshell release shocks may have lead to hardware issues;
Warm atmosphere may have resulted in higher descent rate;

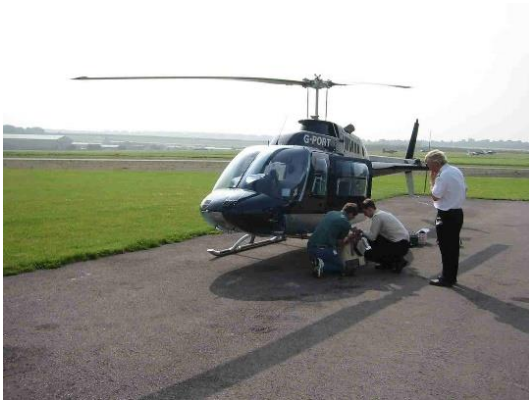
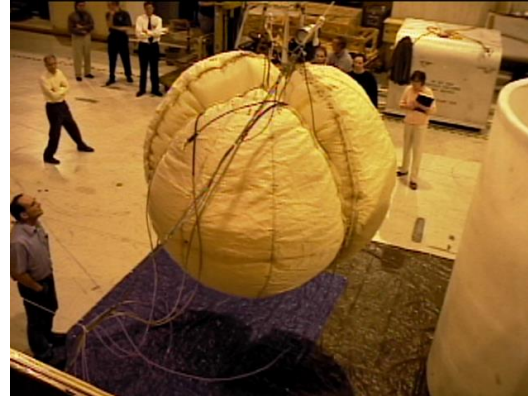
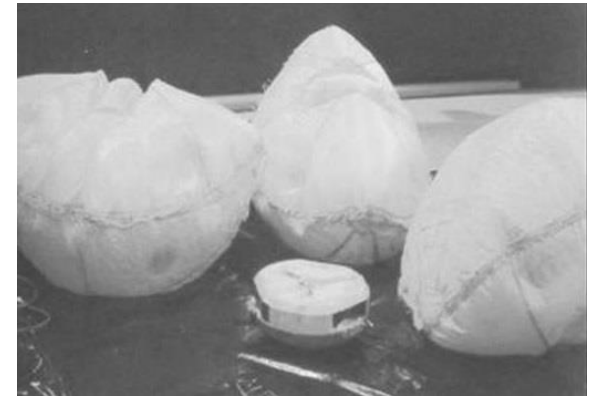
34 more opportunities RAT had 2 thresholds, NSIs non-redundant;
Did airbags have time to fully inflate? Could impacts cause damage?
Did the Airbags & AGS move clear or cause blockage later?

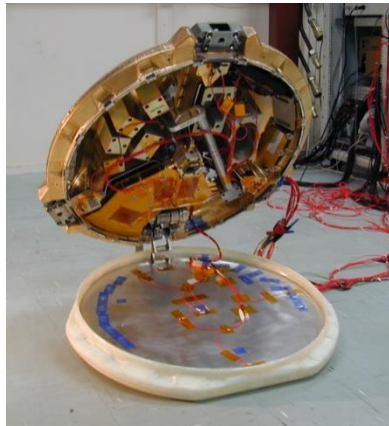
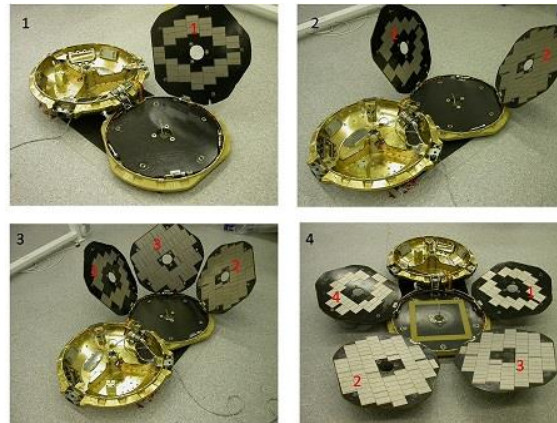
HiRISE image analysis suggest only 1 or 2 solar panels deployed.

A final 59 opportunities with only NSIs non-redundant;
All software worked correctly.
Impact damage, h/w hang-ups or blockage? Battery?

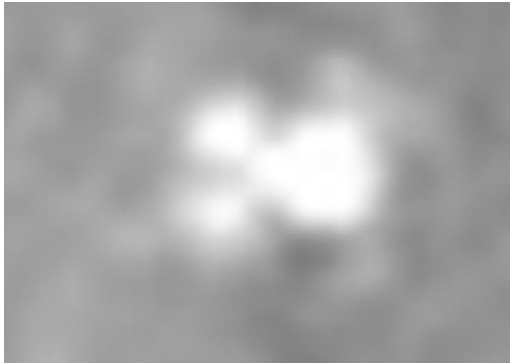
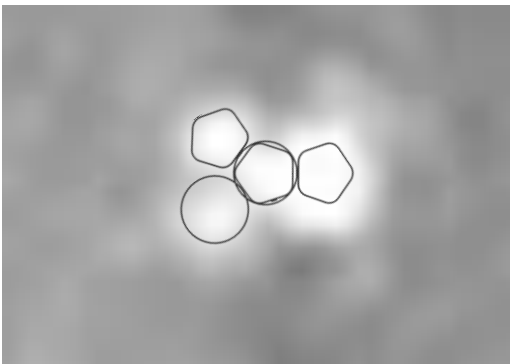
Assuming at least one solar panel deployed

Solar panel deployment started under s/w control but did not complete ##
