Entry, Descent & Landing and Mission Outcome

Dr Jim Clemmet
Beagle 2 Chief Engineer

UK Space Conference
14th July 2015

Beagle 2 Discovered

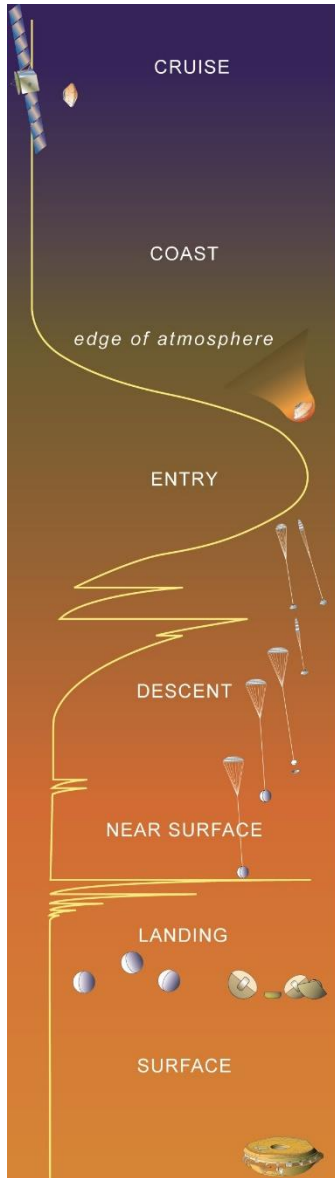
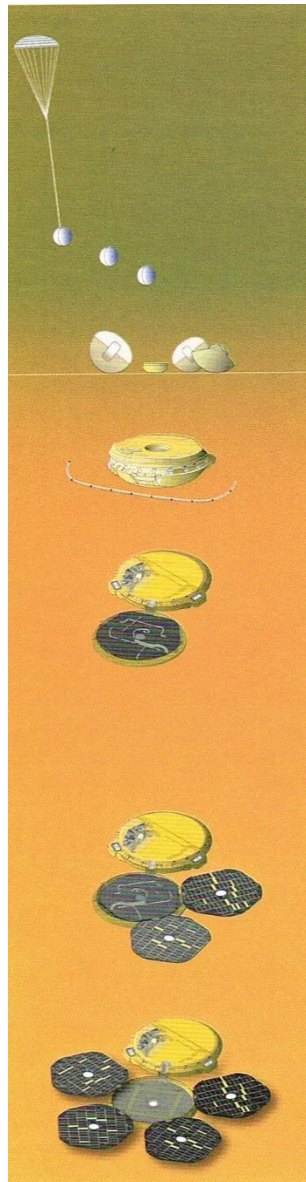
From release from Mars Express to fully deployed on the surface of Mars:

69

steps in the sequence

Many of these have multiples, some not quantifiable, leading

to:

>148

opportunities to fail

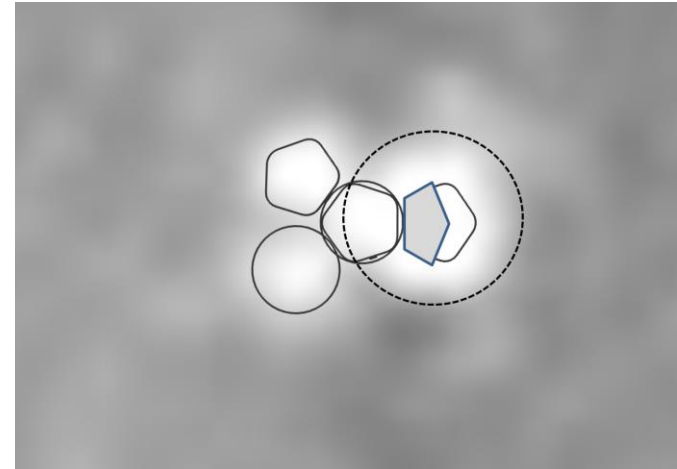
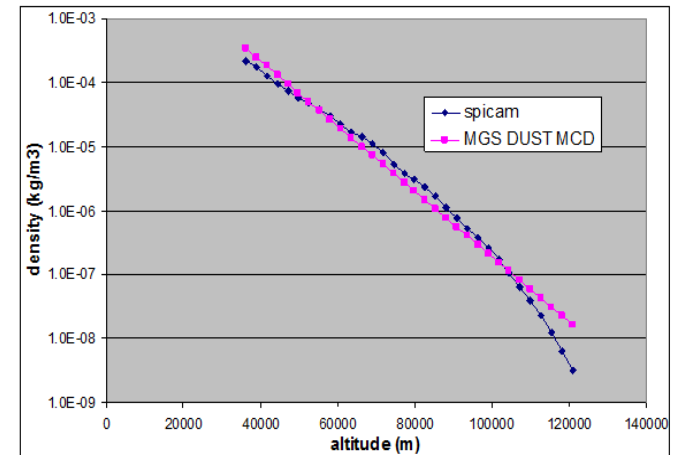
19 candidate functions or events leading to mission loss have been identified.

Numerous potential causes behind each.

- Hardware malfunction or hang-ups
- Impact damage
- Atmosphere or local terrain features.
- All to be assessed further.

But first, more imaging is being requested & analysis methodology being investigate
